SAS Superstructure

Daily Diary Report by Bid Item

Contract No.: 04-0120F4

04-0120F4
04-SF-80-13.2/13.9
Self-Anchored
Suspension Bridge

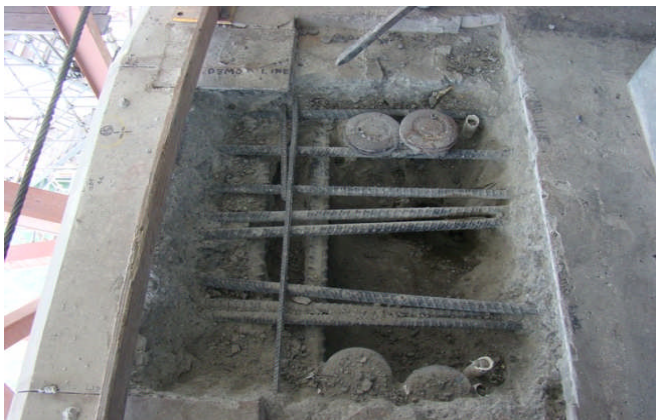
Chipped portion of the E2 cap beam concrete on the west side.

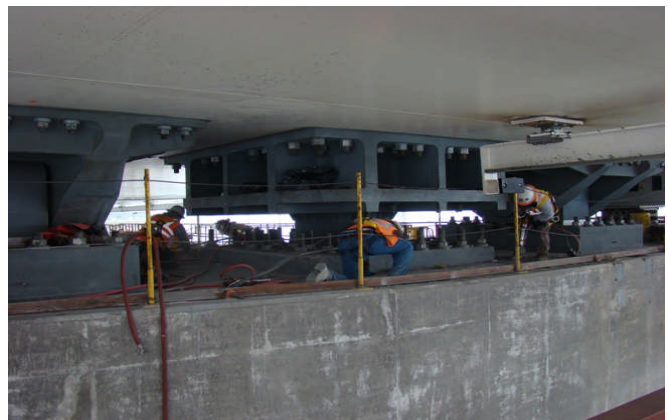
Conco laborers beginning chipping operations today for the S2 Shear Key lower housing retrofit due to the broken anchor rods.

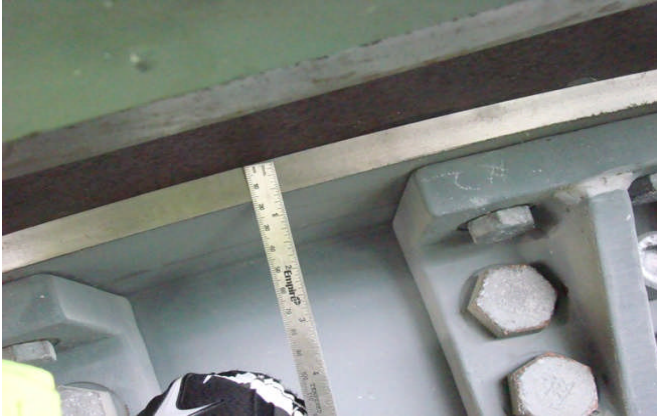
Measured displacement of the S2 Shear Key upper housing on the spherical ring of the lower housing stub seen on west side of 16mm up.

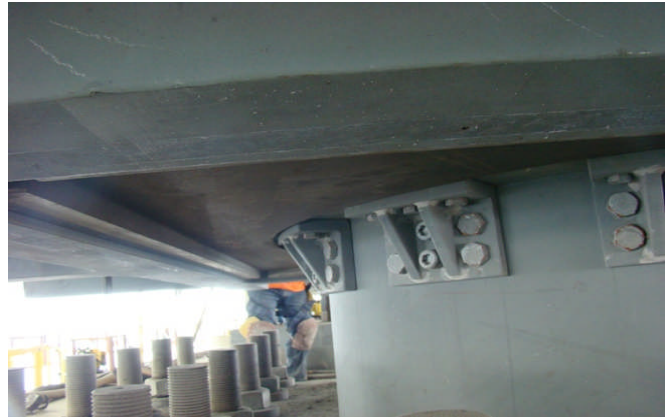
Rotation of the S2 Shear Key upper housing on the spherical ring of the lower housing stub seen on east side looking south.

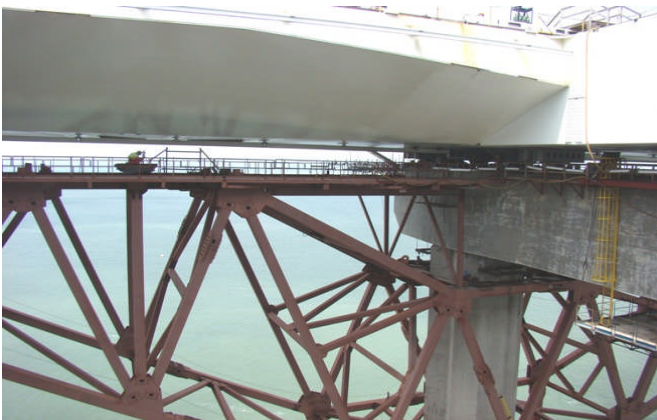
ABF surveyors seen on the W-Line taking preliminary shots on the S1 Shear Key.

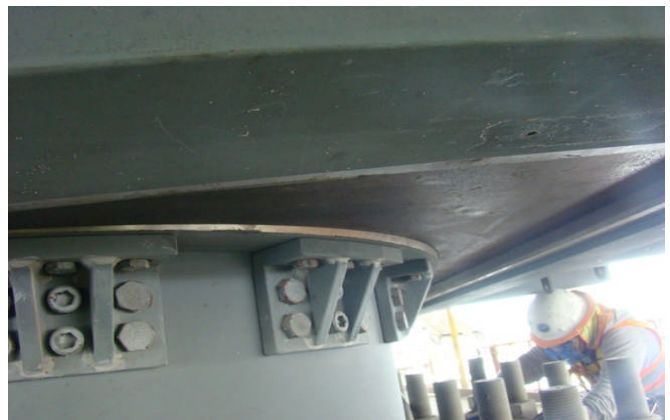
Rotation of the S2 Shear Key upper housing on the spherical ring of the lower housing stub seen on west side looking south.
